# **J. ARONSTEIN**

## **HAZARDOUS FPE CIRCUIT BREAKERS AND PANELS**

*(Updated as of May 25, 2007)*

*Information for Inspectors and Homeowners*

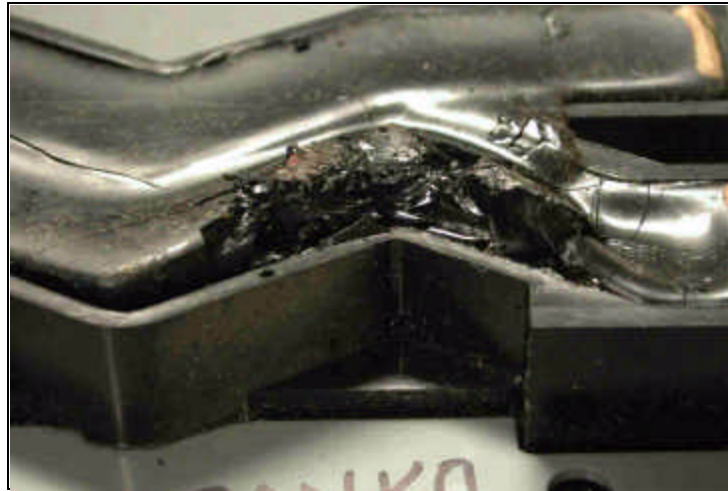
Of the three types illustrated, the one shown in Figure 2-C is known to have a high probability of deteriorating and overheating of the stab socket structures when subjected to significant current flow. Each individual stab socket plate is connected to its bussbar via a post (spacer), and the assembly is held together by an 8-32 steel screw. FPE panels with this construction are prone to overheating failure. The seven panels of the present study that showed evidence of serious overheating were constructed this way. One example is shown in Figure 3.

**FIGURE 3 - OVERHEATING AT THE CONTACT BETWEEN THE BUSSBAR AND THE STAB SOCKET ASSEMBLY CAUSED THIS DAMAGE TO THE INSULATION.**

**(This view is of the backside of the panel. The damage could not be seen unless the panel is taken out of the enclosure.)**

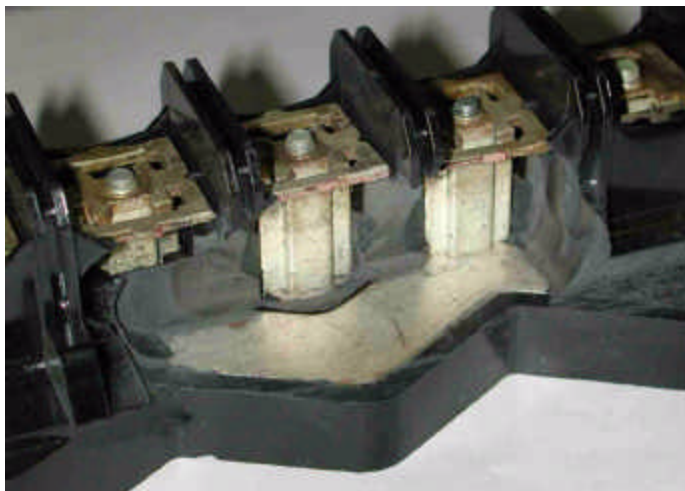
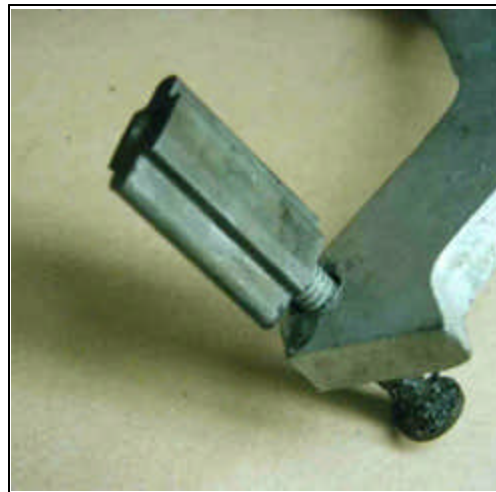
**FIGURE 4 - CONDUCTING PATH FROM BUSSBAR TO STAB SOCKET**

**A. Cutaway - Bussbar, Post, and Stab Socket Plate.**

**B. Bussbar, Screw, and Post**

Various material combinations were utilized by FPE in these assemblies. Some bussbars are copper, others are aluminum. Some posts are copper, others are aluminum. The worst case (most likely to fail) is where both the bussbar and the post are made of aluminum, and the best case (least likely to fail) is where both are made of copper. Inspectors (or homeowners, or electricians) have no way of knowing which materials are utilized in any particular FPE panel with this type of construction.

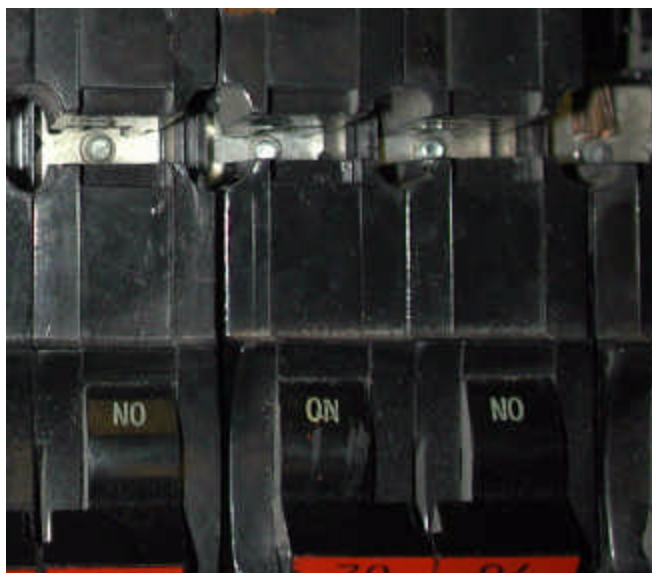
Inspectors can, however, determine if a particular FPE panel has this type of construction, and, to a limited extent, whether it has failing bussbar interconnections that have previously overheated. With the panel cover off, for this type of panel, you can see the ends of the screws holding the stab socket plate as shown in Figure 5. (Note: If you see slotted screwheads, that's a different type of panel construction.) The stab socket plates and the visible ends of the screws should have a bright metallic look. Darkening, discoloration, or signs of corrosion most likely indicate past episodes of abnormal overheating.

**FIGURE 5 - THE ENDS OF THE SCREWS HOLDING THE STAB SOCKET PLATES ARE VISIBLE BETWEEN THE TWO ROWS OF BREAKERS. THIS IDENTIFIES IT AS A PANEL OF THE TYPE SHOWN IN FIGURE 2-C**

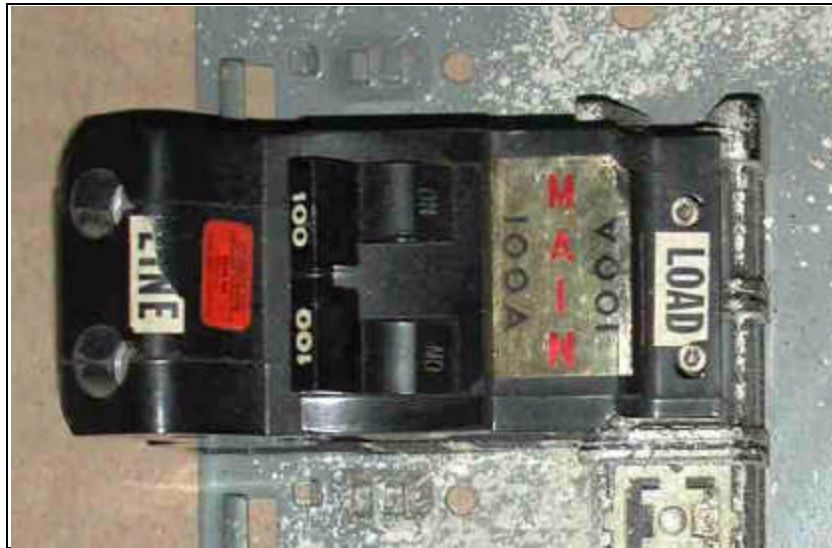
Ten FPE 90 and 100 Amp two-pole main breakers (Figure 6) are included in the results presented in Table 2. Four of the ten failed to trip at 135% of rated current as required.

Some FPE Stab-Lok® panels have 100-amp main breakers that feed into the bussbars through the same plate and post system. In this design, the two main breaker output terminals do not have the stab type contact. Instead, each one is screwed down to a plate the same size as the stab socket plate, but which has a threaded hole in it instead of the stab openings. As with the plate and post assembly, the screws clamping the main breaker terminals are size 8-32, which is absurdly small for clamping the terminals of a 100-amp main breaker.

**FIGURE 6 - FPE 100-AMP MAIN BREAKER CONNECTS TO THE BUSSBARS THROUGH THE PLATE & POST CONFIGURATION, USING ONE SOCKET-HEAD 8-32 SCREW AT EACH TERMINAL TO ATTACH TO THE CONTACT PLATE.**  
(The heads of the 8-32 terminal clamping screws are seen above and below the "LOAD" label.)

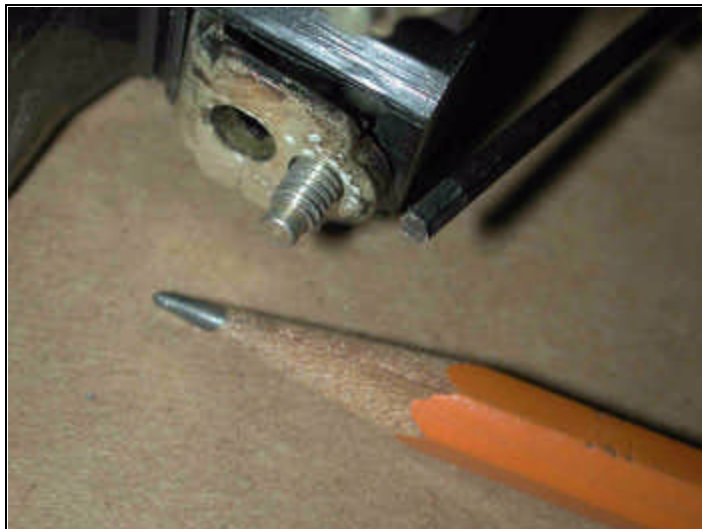
To put the diameter of the 8-32 screw in perspective, it is the same size as used on common receptacles for connecting #14 or #12 copper wire (for 15- and 20-amp circuits), and has a diameter of only about 5/32". An FPE panel and main breaker of this type is shown in Figure 6. The main breaker's output terminal mounting screws and the tiny Allen-wrench that fits them are shown in Figure 7.

**FIGURE 7 - ONE LOAD-SIDE CONTACT AND ITS 8-32 CLAMPING SCREW, ON THE FPE 100-AMP MAIN BREAKER OF FIG. 6. THE SCREW-HEAD TAKES A 3/32" ALLEN WRENCH, WHICH IS ONLY SLIGHTLY LARGER THAN THE LEAD OF THE #2 PENCIL.**  
(The larger hole provides clearance for the screw protruding from the stab contact plate)

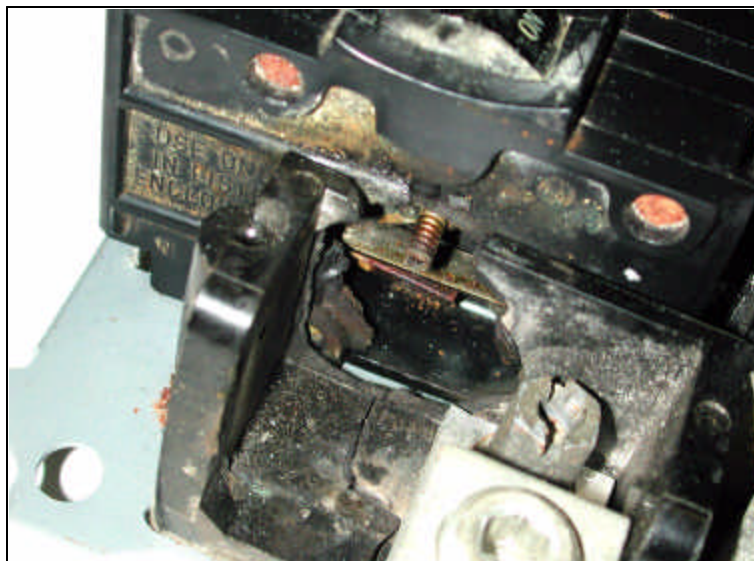
**FIGURE 9 - VIEW DOWN TOWARD UPPER RIGHT OF PANEL SHOWN IN FIG. 8. THE FPE STAB-LOK® TWO-POLE 30-AMP BREAKER FED THE CLOTHES DRYER.**
