# **J. ARONSTEIN**

## **HAZARDOUS FPE CIRCUIT BREAKERS AND PANELS**

*(Updated as of May 25, 2007)*

*Information for Inspectors and Homeowners*

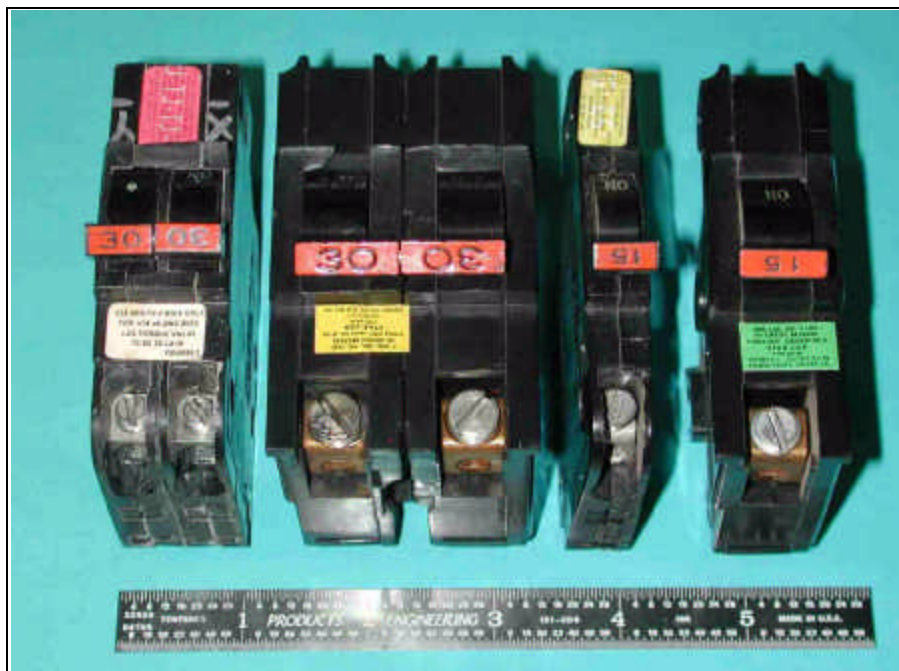
**FIGURE 1 - REPRESENTATIVE SAMPLES OF HALF- AND FULL-WIDTH FPE STAB-LOK® CIRCUIT BREAKERS** (left to right: 1/2-width double pole, full-width double pole, 1/2-width single-pole, full width single-pole)  
*Note that the color and style of the handle varied over the years.*
